Measuring of fuel consumption on Dynapac-roller, monitored by VTI

TEST REPORT

Surveillance of fuel consumption test Unbound base material -

VTI has performed surveillance of fuel consumption tests on a Dynapac roller of model CA 3500D. The roller was tested in three different settings in each test week. The second test week was a duplicate of the first test week. The roller was driven by personnel of Dynapac.

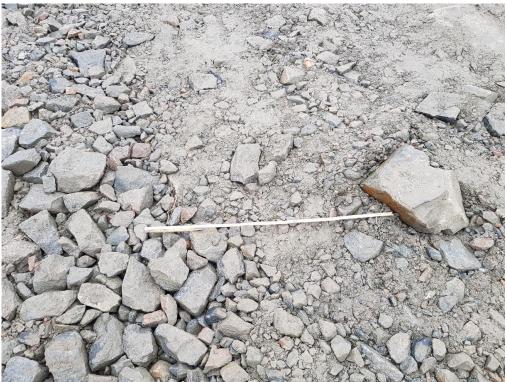
Figure 4. Picture of the material. The ruler is 1 m (1000 mm).

The material being compacted had an approximated grading of 0/150 mm with quite a high content of fines and over size aggregates, see Figure 4 and Figure 5 in Appendix B, Photos (VTI)

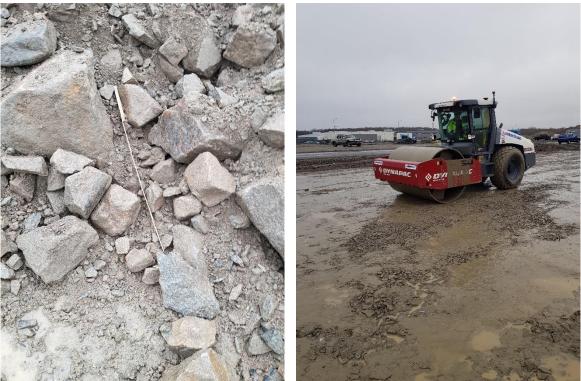
Figure 5. To the left: lose material. To the right: The roller on wet material with high fine content.

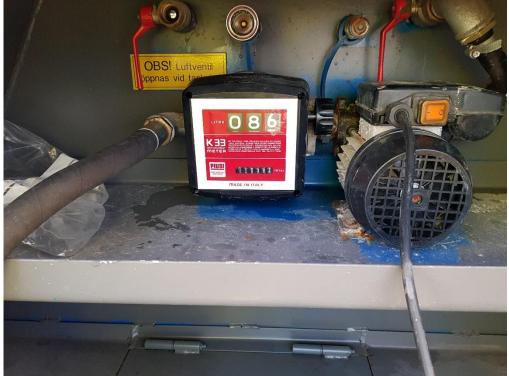
Figure 7. Reading on fuel meter after day 1, week 1. Standard mode with high frequency; 86,5 liters.

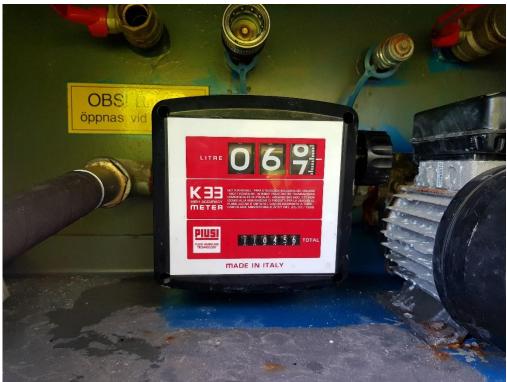
Figure 11. Reading on fuel meter after day 2, week 1. Eco mode; 67,5 liters.

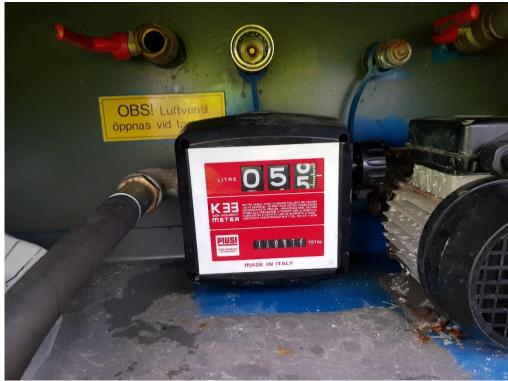
Figure 13. Reading on fuel meter after day 3, week 1. Eco mode + Seismic; 55,4 liters.

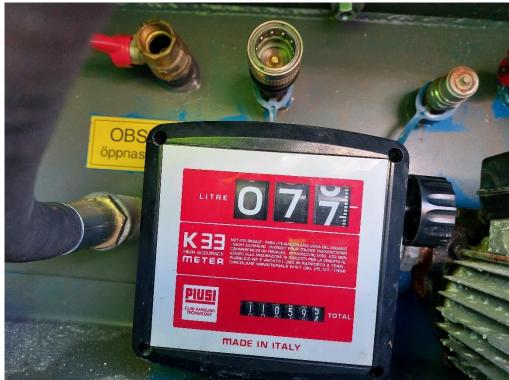
Figure 18. Reading on fuel meter after day 1, week 2. Standard mode with high frequency; 77,3 liters. (Three liters are to little?)

The roller has been at the mechanics during the weekend between week 1 and 2 due to the oil leakage. Therefore, the roller was refueled on the first day of week 2 <u>before</u> starting, to ensure that the work started from a full fuel tank.

The roller was refueled after the work was done every day. However, on the morning of the second day the second week, it was noticed that roller indicated a fuel level of 94%. This could be due to the fact that the roller was parked slightly different (lightly inclined backwards) when refueling the second week compared to the first week. Parking differently was to allow dumper trucks to pass. However, the roller was parked the same way all three days during the second week. Therefore, it is possible that the fuel reading on the first day became a bit low.

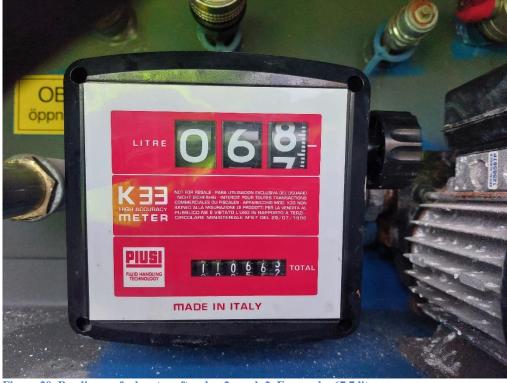
Figure 20. Reading on fuel meter after day 2, week 2. Eco mode; 67,7 liters.

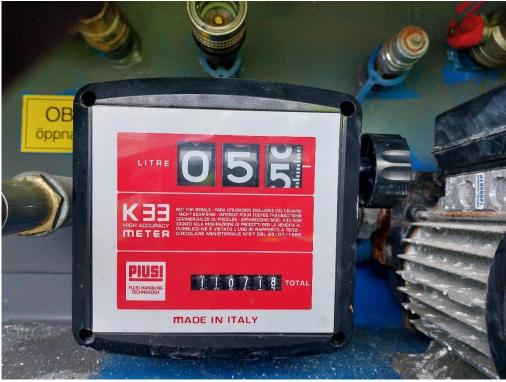
Figure 23. Reading on fuel meter after day 3, week 2. Eco mode + Seismic; 55,4 liters.
